Scoping Notice: Thompson Meadow Restoration Project

The USDA Forest Service, Plumas National Forest, Beckwourth Ranger District proposes activities to restore 40 acres of currently degraded meadow along a 0.6 mile reach of Thompson Creek. The stream channel is currently deeply incised to depths of 4 to 10 feet, resulting in steep, eroding channel banks, depleted groundwater storage, and conversion of the historic meadow vegetation to a xeric, sagebrush-dominated landscape. The primary goals of the project are restoration of historic floodplain function and restoration of the historic meadow water table elevation. Flood flows are currently confined to the incised channel. Streambank erosion is expected to be reduced by spreading flood flows outside of the channel, reducing flow stresses on the banks. Restoration of the water table is expected to restore meadow vegetation communities by allowing plant roots to reach the water table throughout much of the growing season. The current incised channel acts as a drain for meadow moisture, so water table restoration is expected to enhance groundwater storage in the meadow. Wildlife habitat and grazing forage are expected to improve. Thomp

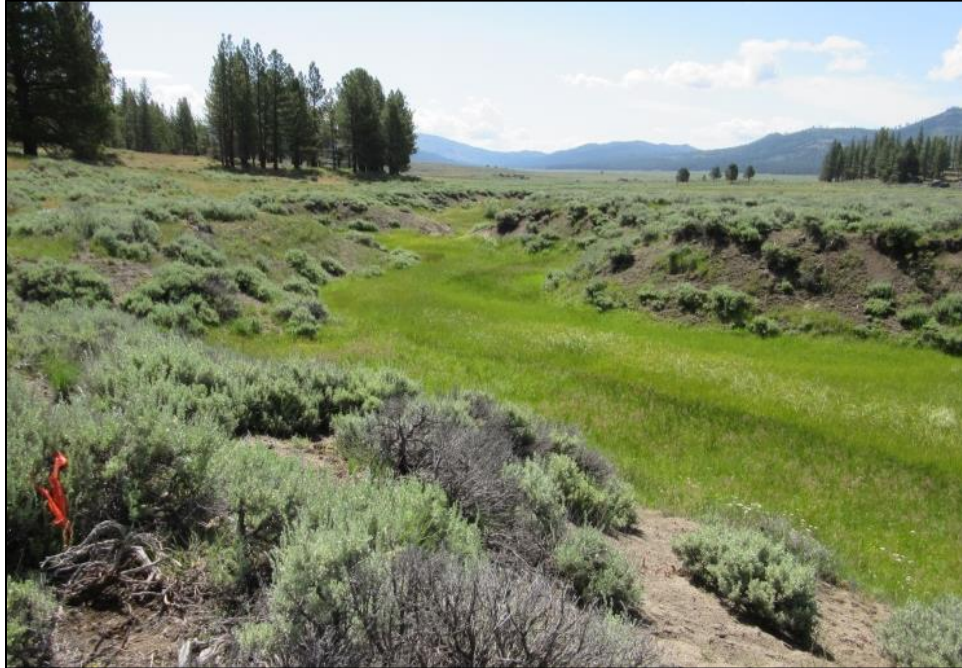
Figure 2: The Thompson Creek channel is currently incised to depths of up to 10 feet, with steep, eroding stream banks. Looking downstream near the downstream end of the first proposed pond-and-plug reach. A portion of the incision to be completely filled is visible in the upper half of this photo. Thick sedge mats from the channel bottom would be transplanted on the surface of the complete fill.

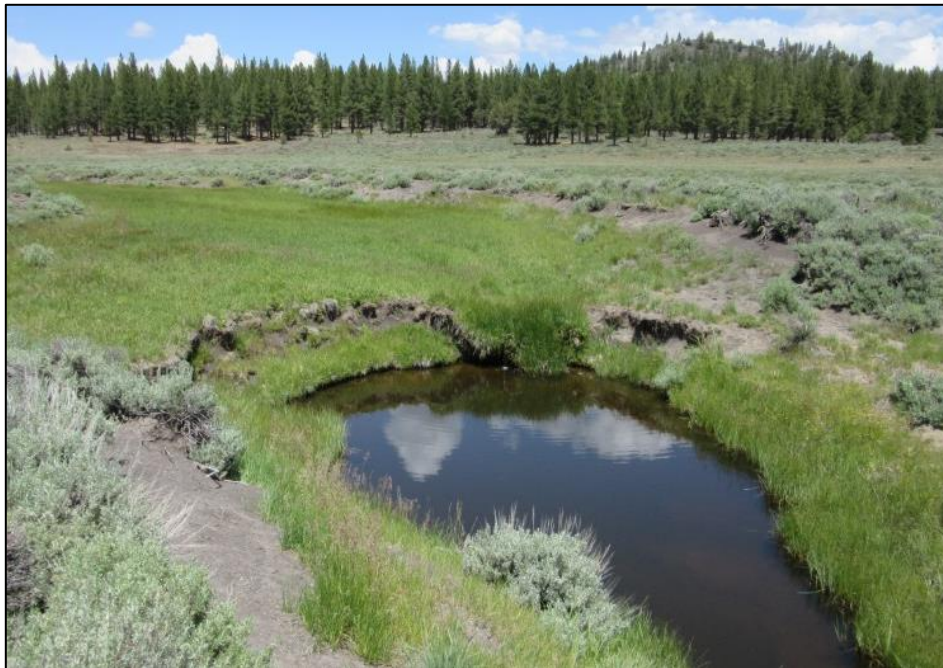
Figure 3: This large headcut currently exists on the Thompson Creek main stem, just upstream of the proposed grade control structure. Looking upstream. A series of rock raised riffle structures would be constructed in the channel shown in the upper half of this photo to raise the meadow water table and spread flood flows onto the meadow.

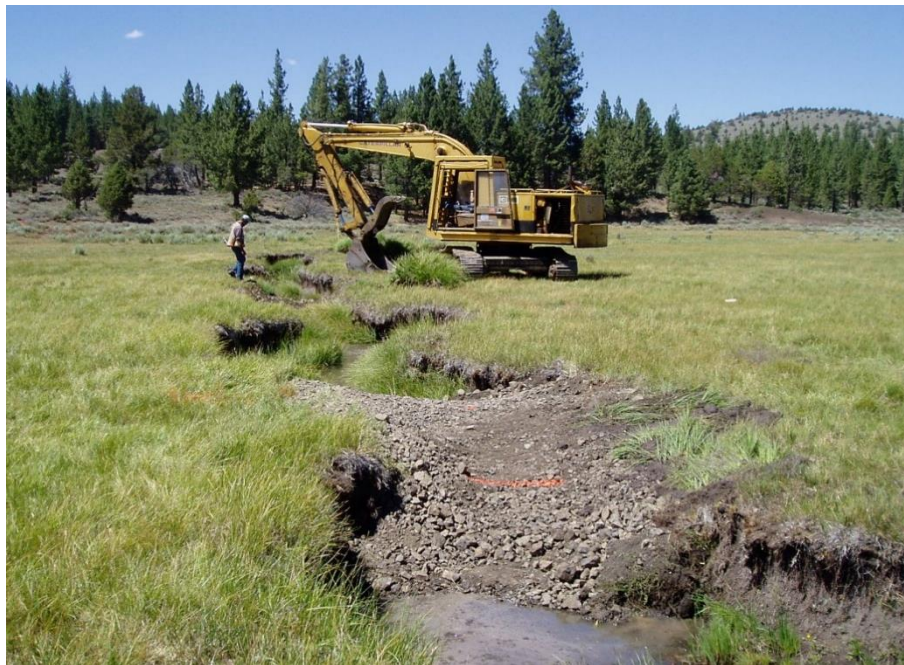
Figure 4: A small “raised riffle” rock structure constructed on Cottonwood Creek (Big Flat). A series of these structures is proposed for a less-incised reach of Thompson Creek to raise the water table in the meadow and spread flood flows onto the meadow surface.

The third restoration technique proposed under Alternative 2, approximately 700 feet in length, would also keep the stream channel in its current location. Floodplain function and water table restoration through this reach would be accomplished with a series of 7 rock “raised riffle” structures. Imported rock would be used to create structures that would raise the channel elevation to within 1.5 feet of the meadow surface, effectively restoring the water table and spreading large flood flows onto the meadow floodplain. The channel incision here is shallow, approximately 4 feet, so the volume of rock for each structure is not prohibitive (each structure would likely require about 150 to 200 cubic yards of imported rock).

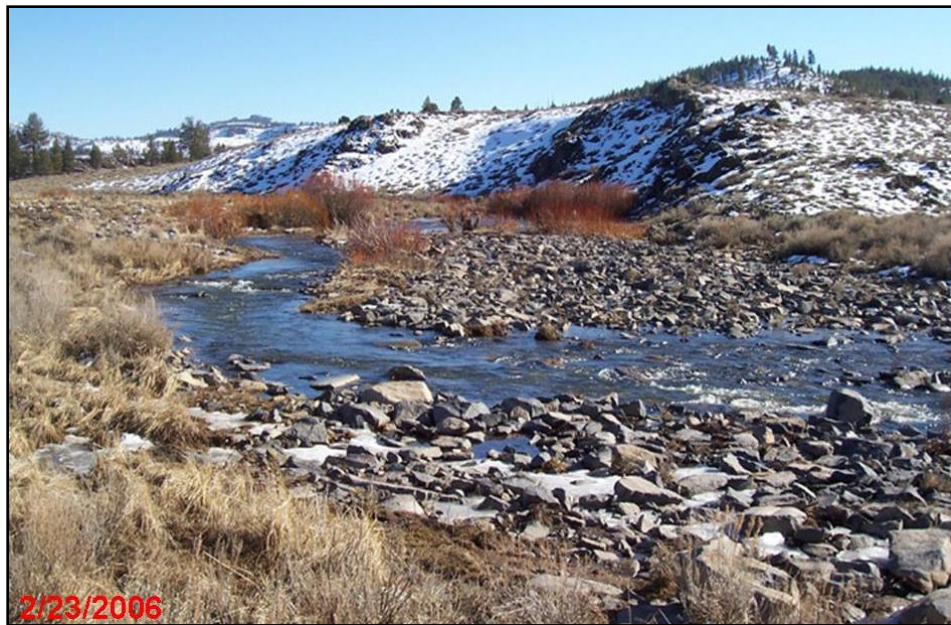
Figure 5: A rock grade control structure with step-pools on Last Chance Creek. Looking upstream. This type of structure is necessary at the downstream end of the project to convey stream flow, including large floods, down an armored surface and connect the restored channel elevation upstream with the untreated incised channel downstream.

The final restoration technique for the main stem of Thompson Creek would be construction of a rock “grade control structure” at the downstream terminus of the project. This armored structure is necessary to convey the stream flow down from meadow elevation into the incised channel outside of the project area. This structure would require large imported rock (up to 3 or 4 feet in diameter), whereas the 7 raised riffle structures on this reach could use smaller rock (2 feet maximum). The control structure would be approximately 8 feet high at its upstream end and would slope gently, dropping just 4 or 5 feet for every 100 feet of length. Step pools would be constructed within the grade control structure base channel to provide fish passage. The structure would be approximately 300 feet long, requiring up to 4,000 cubic yards of imported rock (from USFS’s Crocker Pit), with rock diameters varying from a few inches up to 4 feet. To prevent end-run headcut channels, the grade control structure would be located at a rock outcrop area where the valley and meadow floodplain funnels flood flows over the hardened structure.
